Lattice Radiant Software 2.2 Release Notes

Known Issues for Radiant Software 2.2

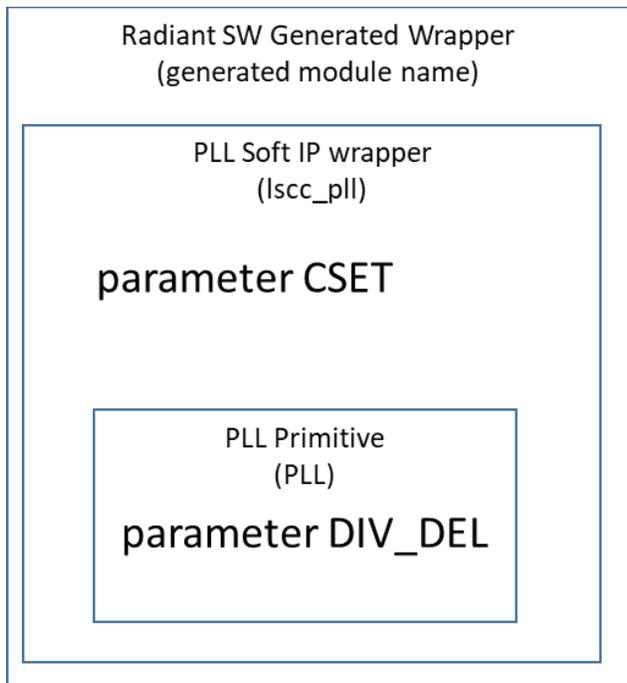
Issue#1 – DIV_DEL attribute is not set by the PLL Soft IP

The PLL can be unstable for certain configurations and not be able to produce correct frequencies.

Workaround: Set DIV_DEL parameter

DIV_DEL parameter

- This parameter is not visible in the wrapper.
- Search the PLL primitive module instance and assign a value to the DIV_DEL parameter.
- DIV_DEL should have the same value as the output divider of the clock selected as feedback (in 7bit binary format).
- For example, if CLKOP is selected as feedback clock and the CLKOP output divider is 1 (DIVOP_ACTUAL_STR == "1"), then DIV_DEL should be set to "0b0000001"

.DIV_DEL() → .DIV_DEL("0b0000001")
